REMEDIAL MEASURES FOR  
HOUSES DAMAGED BY  
EXPANSIVE CLAY

April 5, 1978

The University of Texas at Arlington  
Under Contract No. H-2240-R

U.S. Department of Housing and Urban Development  
Office of Policy Development and Research

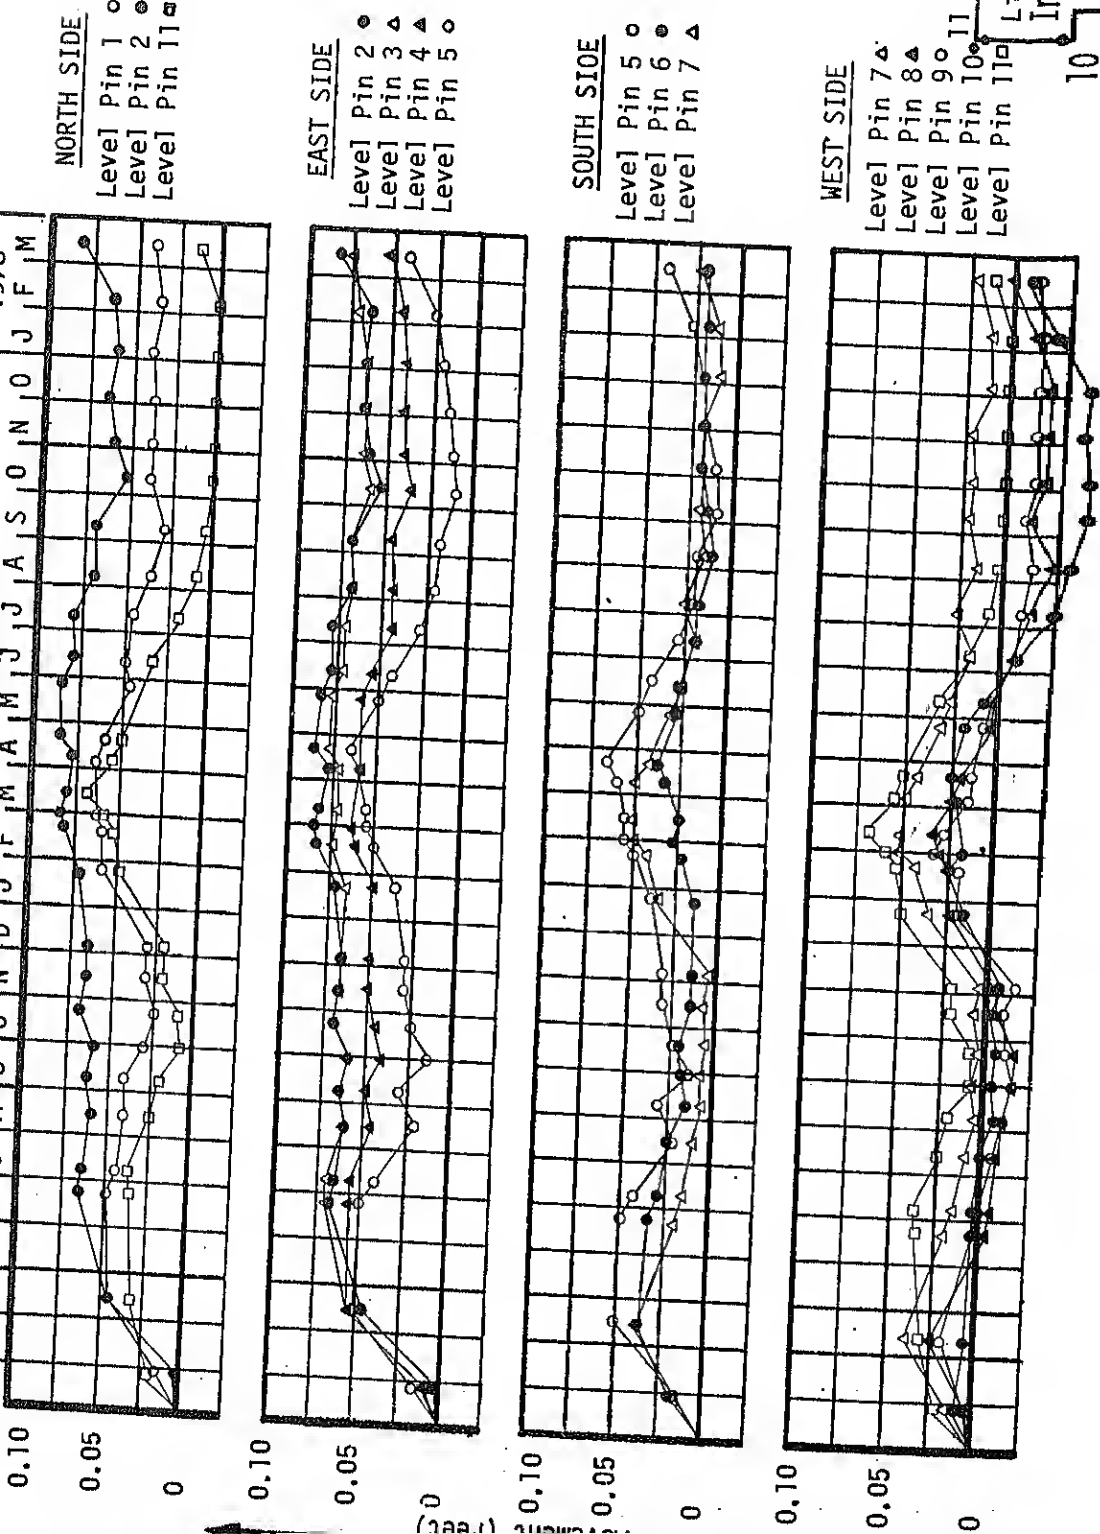
Fig. 11 Vertical m.

An increase in vertical movement occurred as expected due to the development of double layer water on the clay minerals. This increase will continue until equilibrium is reached and then fluctuate with climatic cycle. The vertical movement increase was related to the amount of moisture available, the degree of desiccation of the foundation soil, and the amount of clay minerals in the montmorillonite group present in the soil to the depth of moisture migration.

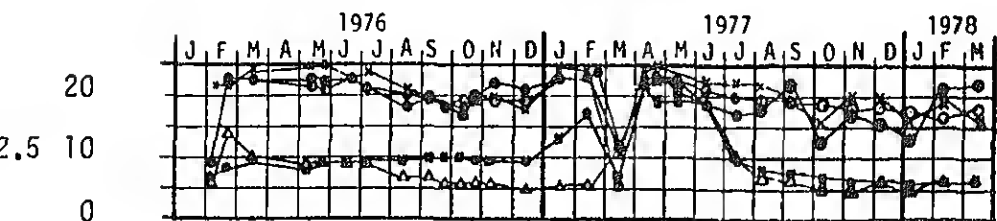
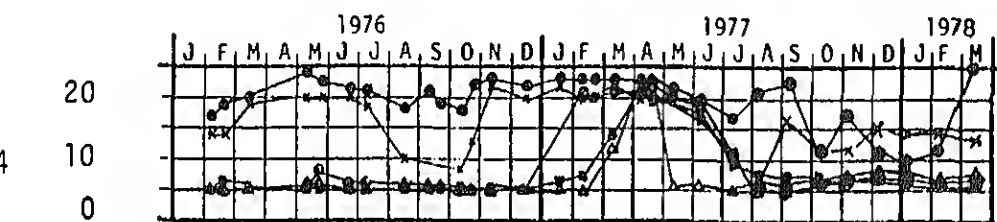
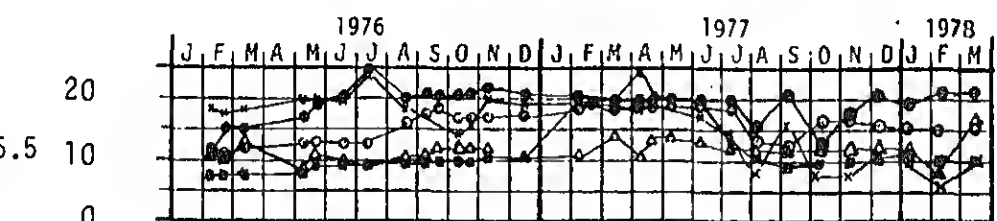
Fig. 16 Soil Moisture Content - Lime Slurry Injection  
830 N.E. 32nd Street, Grand Prairie, Texas

The variation of soil moisture content with time for these two different geologic formations is as dramatic as the variation in vertical movements. From the soils investigation for these two houses, the soil properties such as natural water content, Plastic Limit, and Liquid Limit were significantly higher in the Taylor formation, or the house located at 1000 West Drive, Mesquite, Texas. Further, the natural water content of the soil at 7 foot depth for the Taylor formation was significantly lower than the Plastic Limit of the soil. Within depths of interest in this investigation, the maximum amount of soil moisture variation was as much as 11% below the Plastic Limit in the Taylor formation, whereas in the Eagle Ford formation 5% below the Plastic Limit appeared to be maximum. In addition, the percentage of montmorillonite clay minerals determined by x-ray Diffraction Analysis was much greater in the Taylor formation than in the Eagle Ford formation. For depths of interest at the soil surface, the increase (in what) was as much as 45 percent at the 1000 West elevations and 20 percent at the 7 foot depth. The lime slurry was laterally inserted to this depth; however, the extent of the moisture migration vertically and laterally along fissures and planes of weakness was unknown, and it would be a function of the degree of desiccation and past geologic history. However, it is believed that moisture migration was wide spread for pressures of 150 psi, and both, the vertical movements and moisture migration support this premise.

The high specific surface area of montmorillonite clay minerals (100 square meters per gram), along with the large volume of water introduced into the profile of the house located on the Taylor formation versus the house on the Eagle Ford formation indicates the subsoil under the house at 1000 West Drive, Mesquite, Texas, was capable of retaining more moisture. Referenced on page 30, which compares the maximum perimeter differential movements for the house where the subsoil was treated by lime slurry pressure injection. This figure indicates the significant difference in activity of the subsoil for the houses on the Taylor and Eagle Ford formations. Similar indications are given by comparing Figures 11 and 13, pages 22 and 26, which show

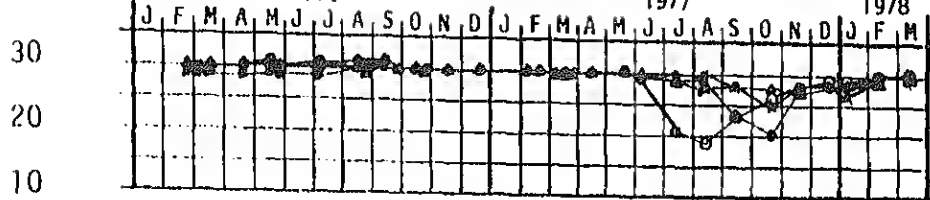
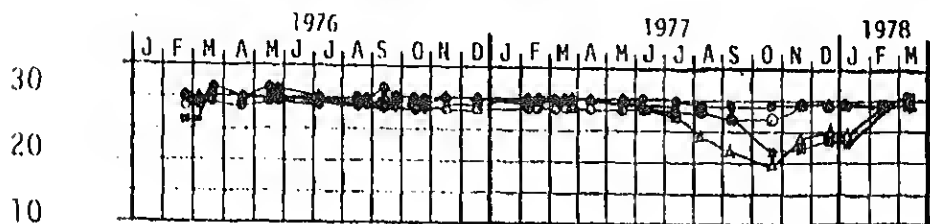
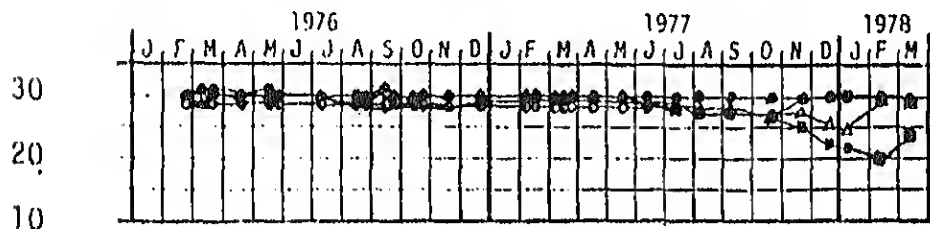
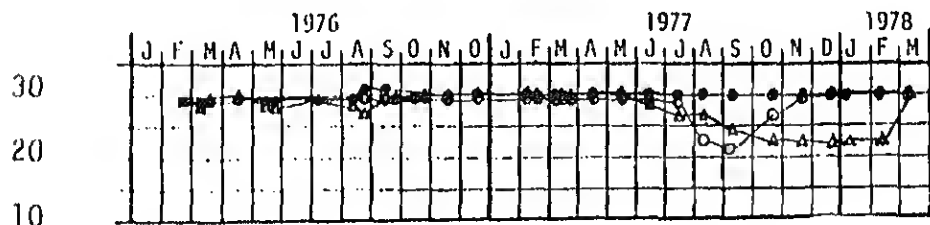
\* Refers to Depths Below Perimeter Grade Beam  
 Fig. 36 Soil Moisture Content - Rubber Barrier  
 1314 Athens Street, Mesquite, Texas

is submitted that an undetermined volume of the added water was lost to significant depths in the subsoil and also to soil outside the rubber barrier by the ready avenues of escape provided by fractures and cracks in the formation subsoil. As the soil expanded and gradually restricted these flow paths, the increase in soil moisture was obtained in the soil mass surrounded by the rubber barrier.

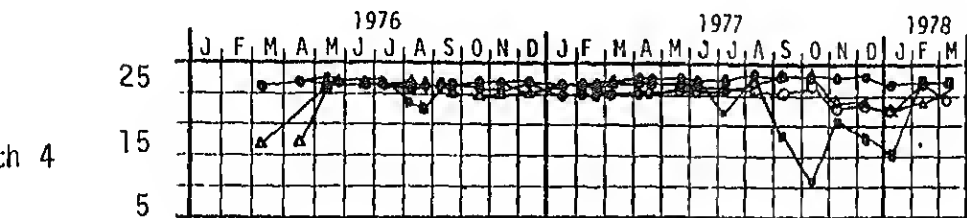
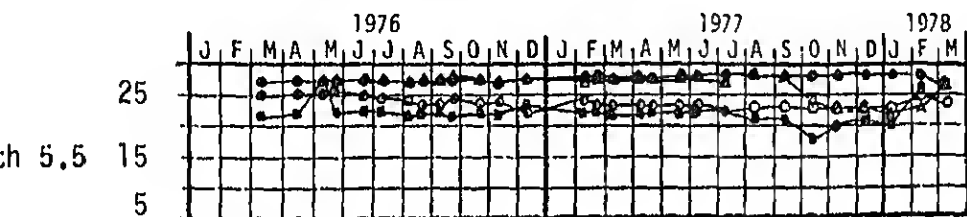
Fig. 43 Soil Moisture Content - Lean Concrete Barrier  
1137 Eastwood Drive, Lewisville, Texas

As given in Section 4.4.1, 9,827 gallons of water were added to the soils beneath the floor slab and surrounded by the concrete barrier. Further, the entire volume of water was added to the soil from the interior of the house. The floor slab had a "cupped" configuration, and borings were made through the slab on the interior of the house governed by the high and low points determined by topographical survey. Further, testing of the soils in the upper five feet to determine whether or not the moisture content was increased to the minimum desired was also accomplished at the access points from the interior of the house. The moisture-temperature cells are installed in borings approximately 12-18 inches from the house perimeter which may result in the moisture gradient decreasing and recording less than the optimum of the instruments. If the preceding was the case, it is then possible that the installed instruments and the insitu soil do not have completely intimate contact resulting in readings that are less than desirable. The mass of soil enclosed by the vertical concrete barrier could have different moisture contents throughout and particularly have higher moisture contents at the in-

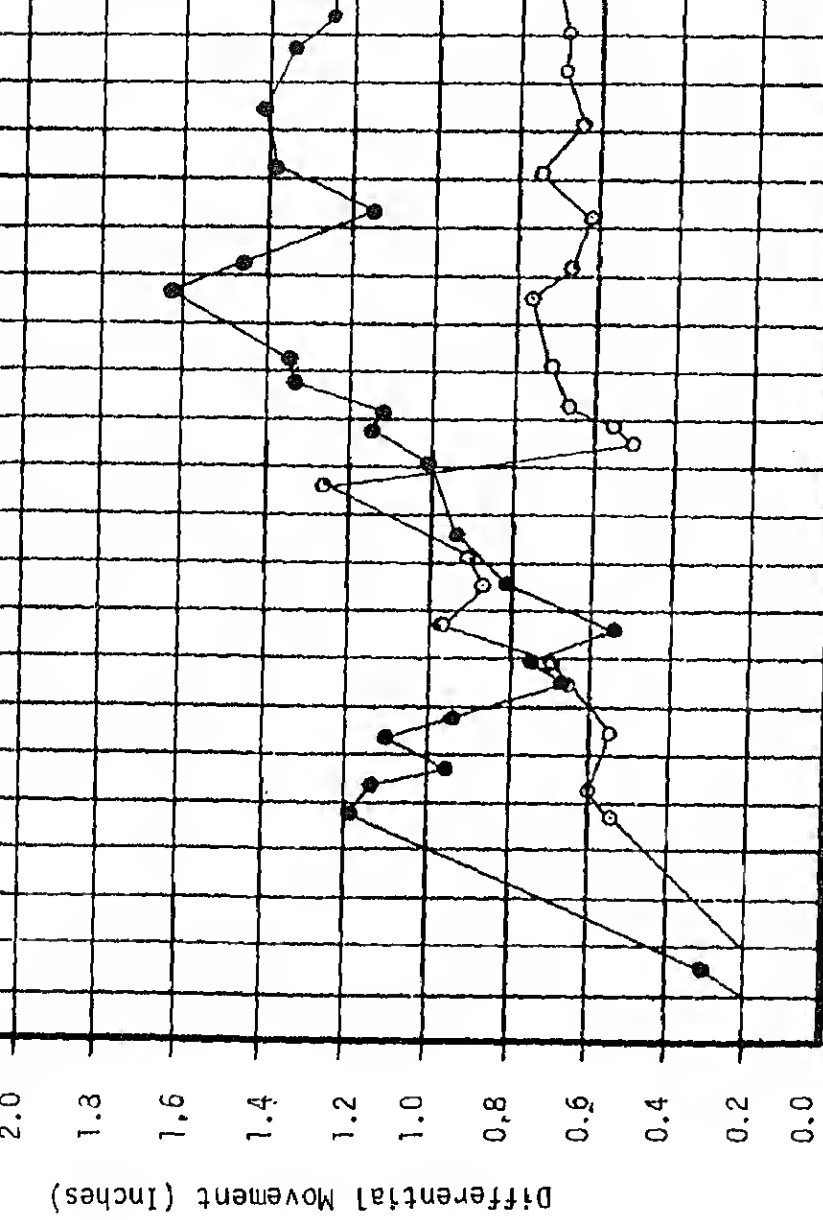
Fig. 51 Maximum Perimeter Differential Movement Comparison on  
 Different Geologic Formations Sub-Surface Irrigation Sys

Comparison of the two test houses on two geologic formations is only possible during the period of time both systems are functioning. For this period, the SIS performed remarkably well on the Eagle Ford with vertical movements being approximately one half of the vertical movements for the house on the Taylor formation. Figure 51 and Tables 30 and 31 show absolute values of movement around the perimeter of the house. The data for the house at 5807 Fess Street, Dallas, Texas is factual. The data given for
